PROJECT CASE STUDY

# IN-SITU REMEDIATION OF AN MOD ASSET

REDS Group was commissioned to redevelop a Motor Transport Fuel Installation (MTFI) facility at a MOD site in South West England.

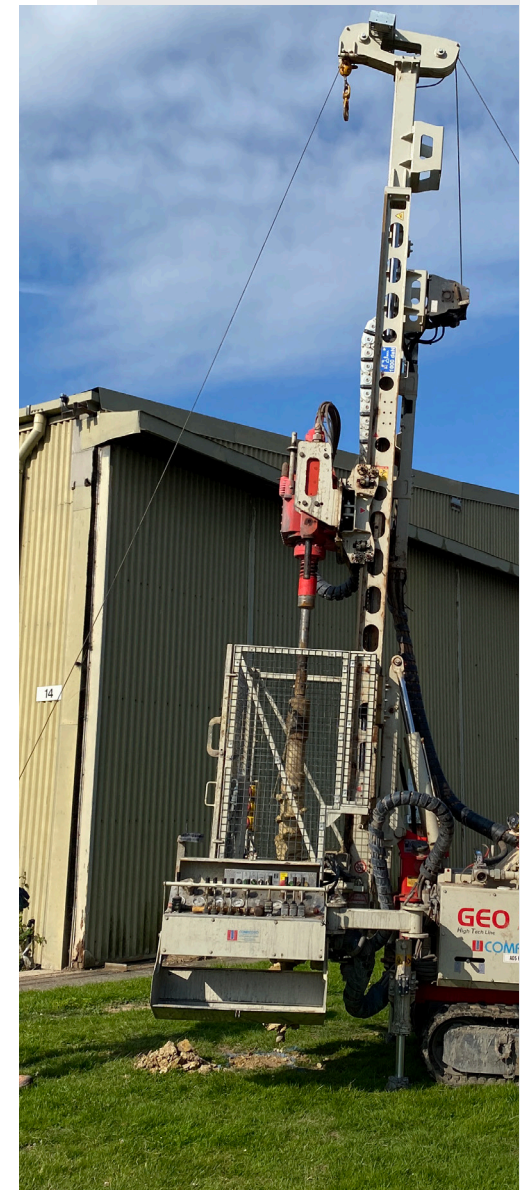
During the redevelopment works, a previously unrecorded former below ground tank installation was encountered with associated residual hydrocarbon contamination.

The former tank vault had been backfilled with poorly compacted mass concrete and remnants of the former forecourt infrastructure, with a section of the former foundation structure also remaining in-situ. These all needed to be removed to provide a suitable foundation platform for the new tanks. Initial remedial works were carried out as part of the redevelopment works with removal of free phase hydrocarbons and grossly contaminated soils comprising a contaminant source removal strategy.

Geology was proved to comprise clay soils to ~3.5m depth, overlying sand and gravel units. Impact of underlying groundwater in the deeper sand and gravel had occurred, with lateral migration of a hydrocarbon plume identified to the south of the site.

Due to the depth of the residual contamination, we concluded further excavation of contamination to be unsustainable. We completed a revised Detailed Quantitative Risk Assessment to derive suitable site-specific remedial targets for the site and inform the remedial strategy to address the residual contamination of underlying groundwater.

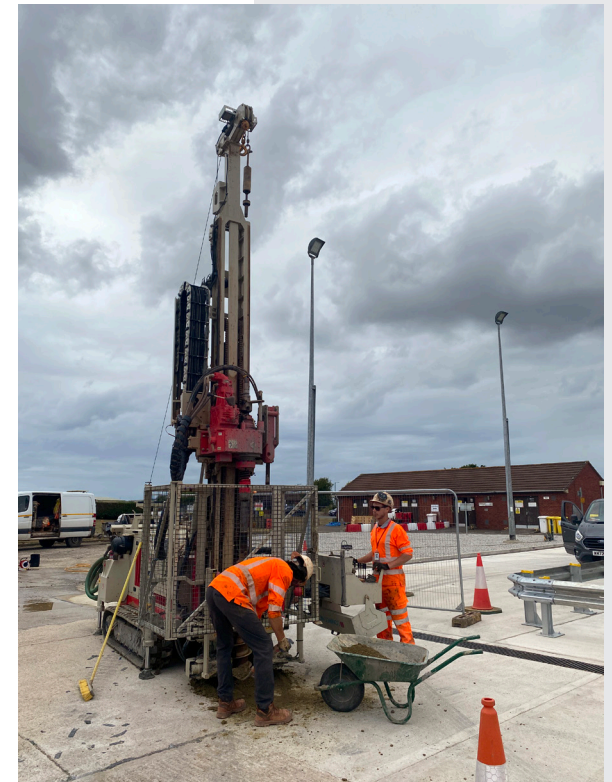
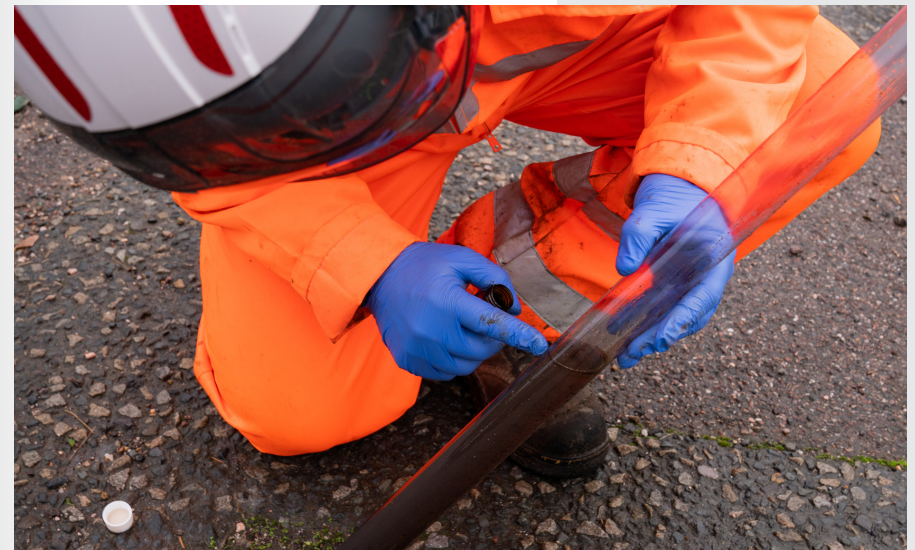
Initial treatment of the residual hydrocarbon plume to the south of the new fuel installation was completed using In-Situ Chemical Oxidation (ISCO). We constructed temporary injection wells and additional sentinel monitoring wells at the site and then injected reagents into the underlying gravel aquifer using our chemical mixing and injection system via the installed treatment well network.

Due to the confined nature of the underlying aquifer, injection of the reagent solution was completed daily into each location over the course of three days to ensure suitable volumes were introduced into the residual hydrocarbon plume. Each location was then injected with clean water to further distribute the reagent into the aquifer.

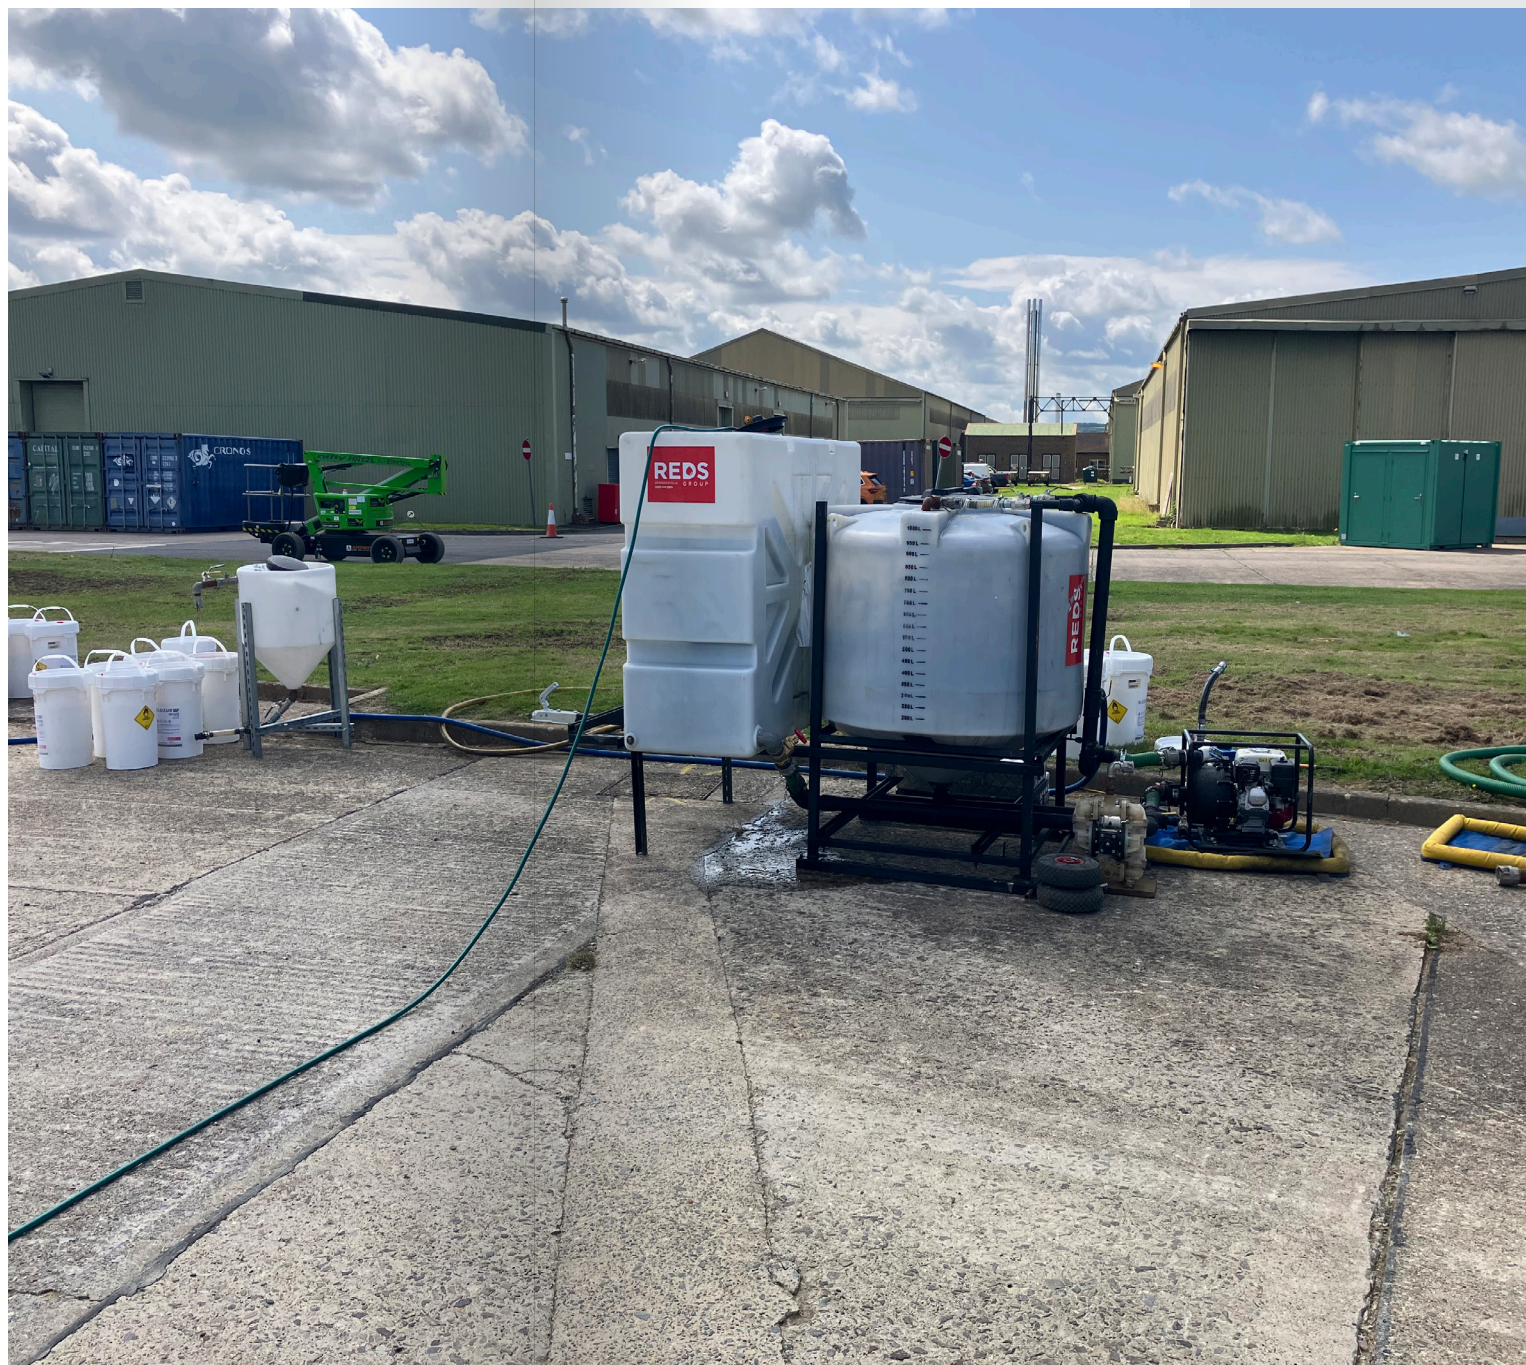
The final phase of our in-situ remedial treatment work was completed via follow-on treatment of underlying saturated soils and groundwater using Oxygen Releasing Substrate (ORS). These are designed to release oxygen directly into the dissolved phase contaminant plume over a 9 to 12 month period, enabling aerobic microbes to significantly accelerate rates of bioremediation, without loss of oxygen to the atmosphere.

Again, the ORS was injected into the underlying gravel aquifer in solution using our chemical mixing and injection system. We then removed the temporary injection wells and reinstated the concrete pavement at each location.

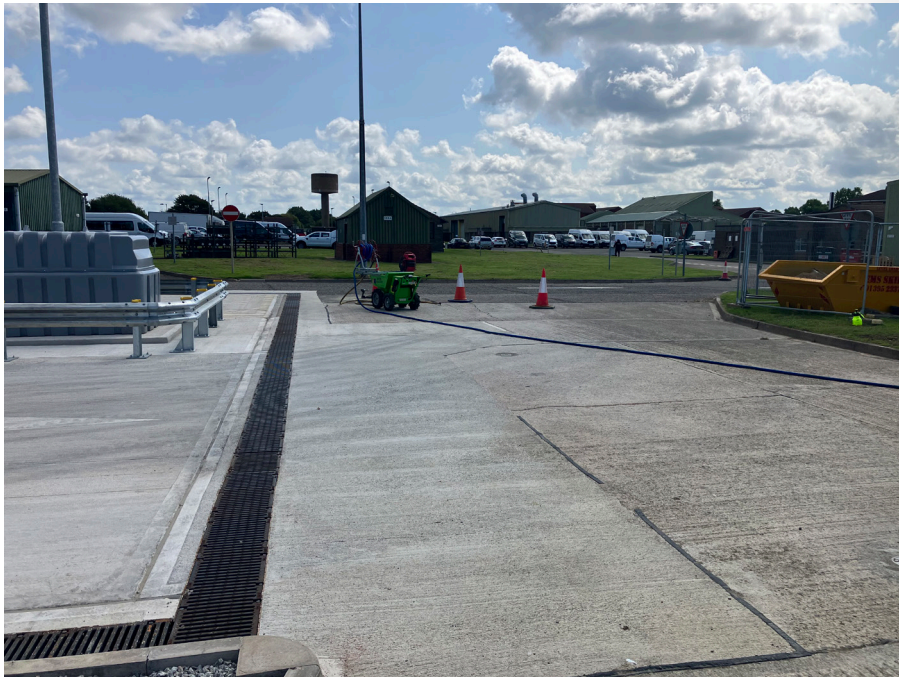
## FIGURES SHOWING HYDROCARBON CONCENTRATIONS IN GROUNDWATER BEFORE AND AFTER REMEDIAL WORK

Post-remedial verification monitoring was completed during a series of return visits to the site. Groundwater samples were collected using low-flow sampling techniques and key groundwater parameters reviewed to confirm natural attenuation processes were active.

Dissolved hydrocarbons fell rapidly following our remedial works, reducing in concentration by >95%. None of the hydrocarbon concentrations recorded in groundwater post-remediation were found to exceed the site-specific remedial target levels for the site.

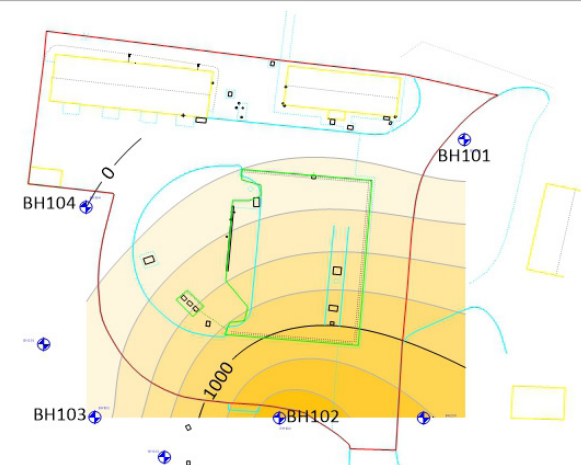
Concentrations after.

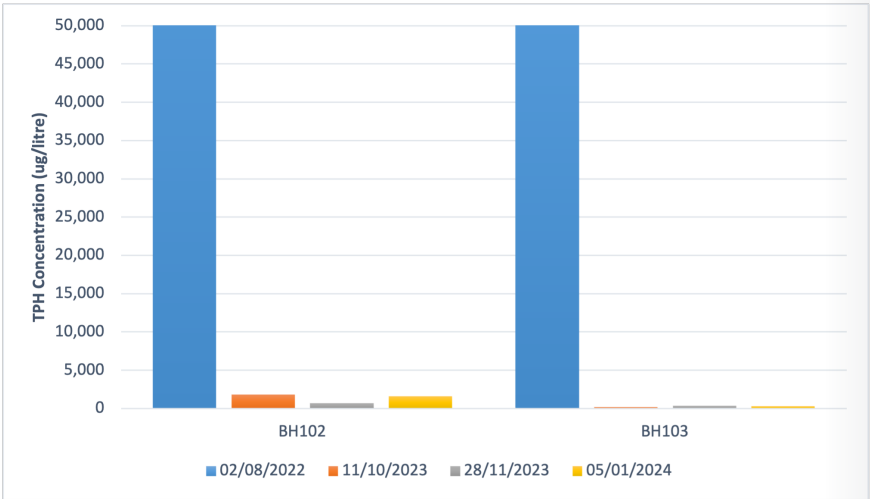
Graph showing reduction in hydrocarbon concentration in groundwater following remediation work.
