Listed Historic  
Estate, UK  
Spill Response,  
Investigation &  
Remediation Works

Case Study

## Project Scope

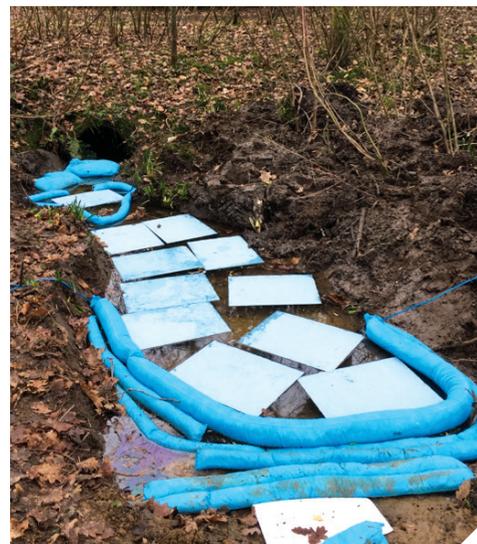
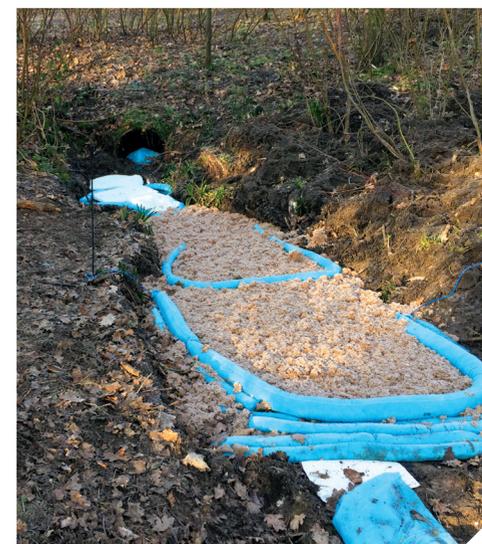
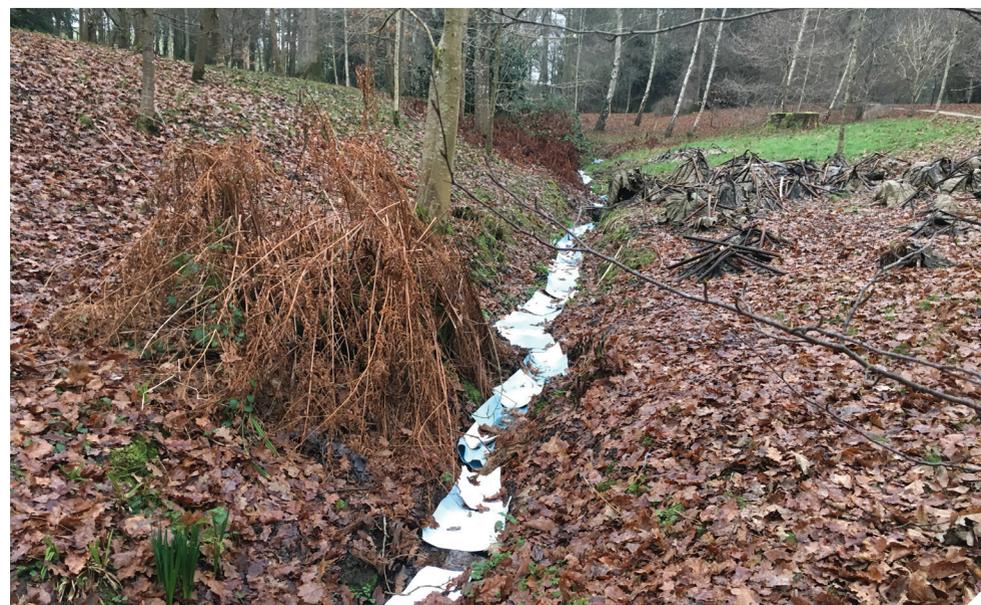
Once REDS' RRV and initial responder arrived on site, fuel absorbents and barrier booms were placed in the path of migration to prevent further impact of fuel oil. These containment measures bolstered the prevention measures installed by site staff. The storage tank was also checked over and secured, as well as all site drainage in the immediate area.

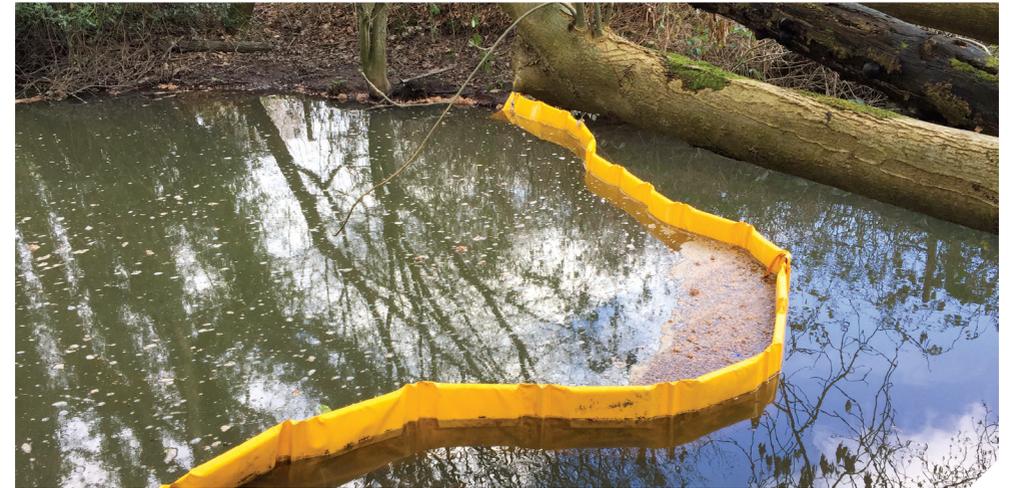
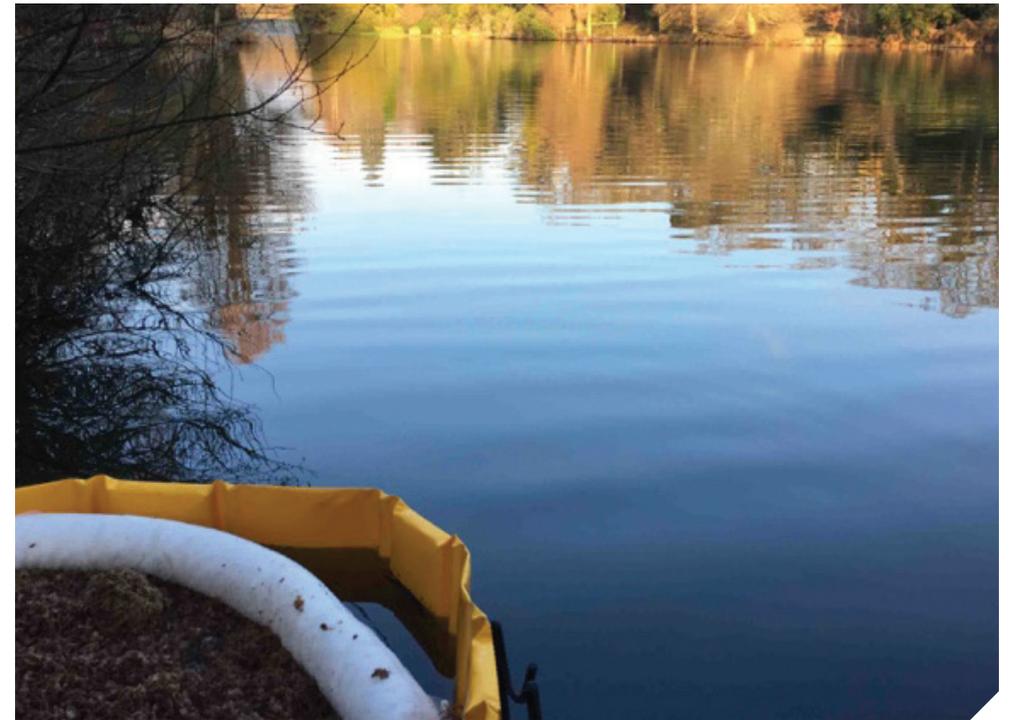
Once containment was secure, a detailed investigation from the source of the spill downstream to the open waterways was undertaken to assess the risk and the receptors, and to plan appropriate mitigating actions.

This investigation included chemical analysis of surface water and sediments, visual inspection of the river network and analysis of Volatile Organic Compounds within adjacent buildings.

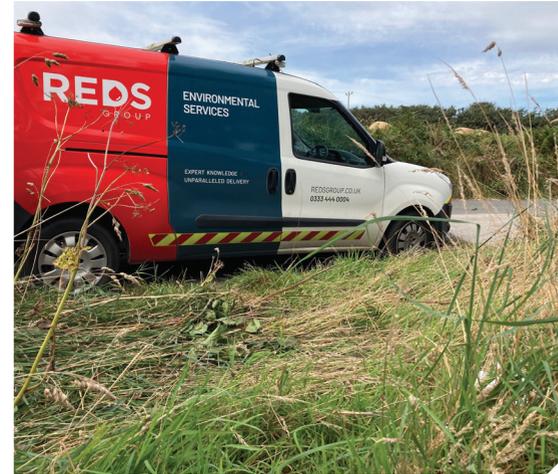
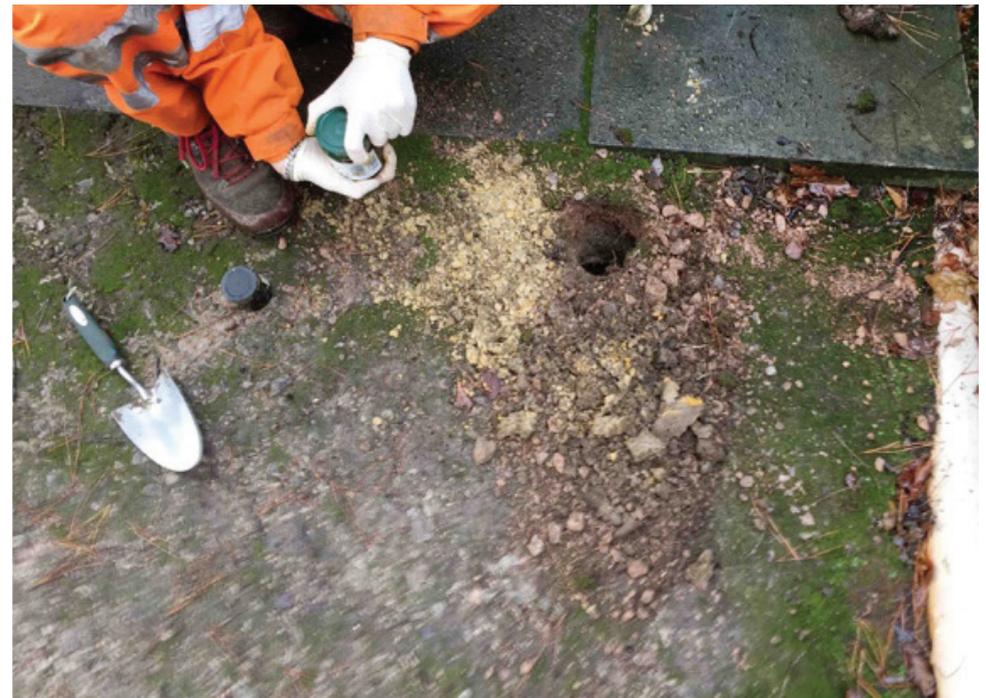
The remediation strategy implemented three techniques:

Removal of contaminated organic matter and sediment

Uplift of free-phase fuel

Removal and replacement of saturated absorbents

This included visual monitoring to identify the migration of free-phase fuel, and chemical analysis of the water quality to identify dissolved contaminants. During this monitoring, and due to contamination removal activities by REDS Group, a reduction in contaminants was observed, resulting in acceptable levels when compared to Environmental Quality Standards as agreed by the Environment Agency and the client.
